# Gem Trade LAB NOTES

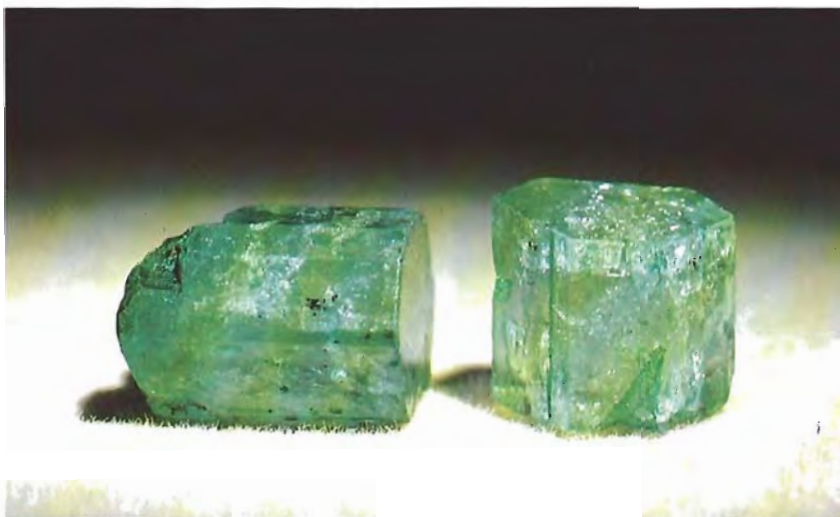
Several months after this cut stone was tested, we had the opportunity to examine two rough beryl crystals (weighing 15.1 and 10.91 ct, respectively) that had been treated in a very similar manner (figure 4). On these crystals the green coating had been partially removed from the flat surfaces and was present mostly in surface fractures, cavities, and depressions. As with the cut stone described above, the coating flaked off with the brush probe, stained the acetone-soaked swab, and melted in response to a thermal reaction tester.

Figure 4. Beryl crystals treated in a manner similar to the stone illustrated in figure 3.

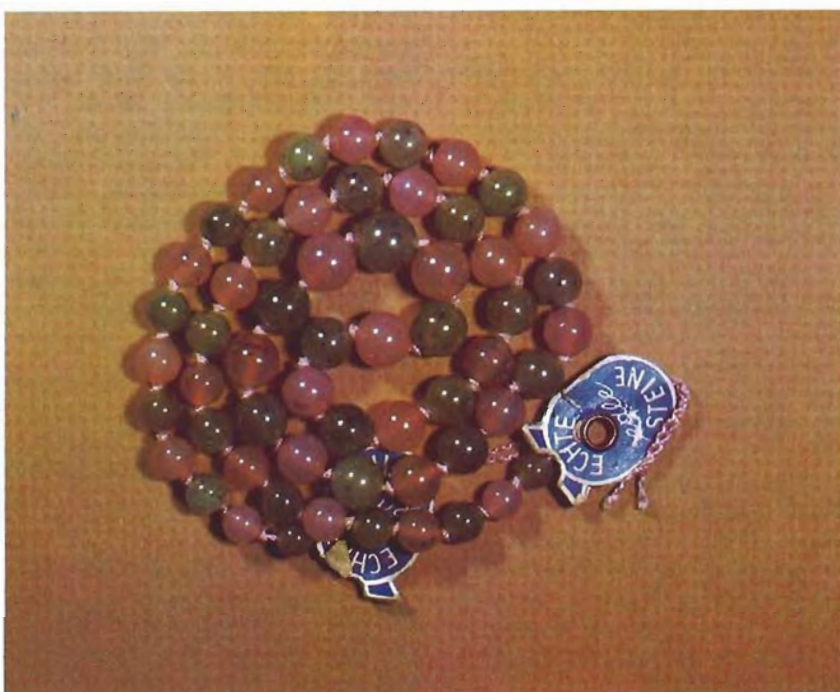
Figure 5. Strand of pink and green grossularite beads, each approximately 9 mm in diameter.

We had nearly forgotten that translucent grossularite garnet occurs in pink as well as green until a beautiful strand of the material, with alternating green and pink beads approximately 9 mm in diameter, was submitted to the New York laboratory for testing (figure 5). It had been offered to the client as "rare jade."

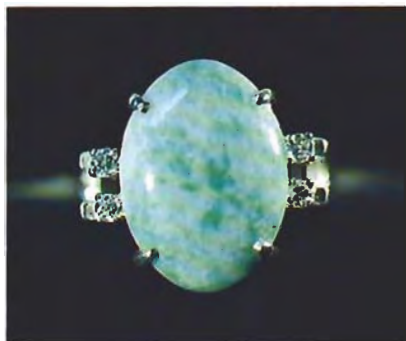
The Los Angeles laboratory received for identification a lady's ring set with a 14.95  $\times$  10.85  $\times$  2.80 mm mottled white-and-green oval cabo-

chon center stone and several diamond side stones (see figure 6). The client explained that the center stone had changed color, in this case from a relatively even medium green to predominantly white with splotches of green, while the ring was being

Figure 6. Loss of color in heat-damaged jadeite ring. Stone measures  $14.95 \times 10.85 \times 2.80$  mm thick.

repaired with a torch. Subsequent testing proved the stone to be natural-colored jadeite. This accident could have been prevented if the jeweler had possessed a fuller understanding of the effects of heat on jadeite.

To circumvent unnecessary accidents such as these, a good rule of thumb to follow is never to heat any gemstone other than diamond and then only when the proper precautions have been taken, such as cleaning the diamond thoroughly and giving it a protective coating. Most diamonds that are in frequently worn jewelry accumulate foreign substances, such as oils and soaps, particularly on pavilion surfaces. When they are subjected to high temperatures, such as would be encountered in retipping a prong, the foreign substances often become charred. These charred surfaces usually have to be boiled in a sulfuric acid bath to be removed; in more severe cases, where the surface of the stone is oxidized, the diamond must be repolished.

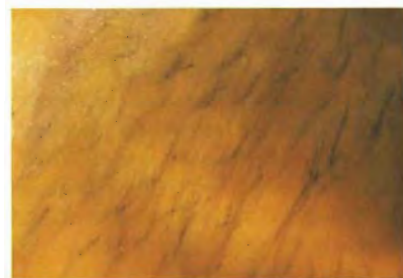
A large, natural, transparent to semitransparent, brownish-orange opal double cabochon brought to the Santa Monica laboratory for identification proved to be quite interesting. The central portion of the opal contained a large, semitranslucent, white subspherical inclusion, which occupied approximately 50% of the entire volume of the opal. Trailing down the sides of the white inclusion were numerous smoke-like dark brown to black steamers, as shown in figure 8. The central white inclusion could possibly be cristobalite, another form of silica, but no tests could be carried out to prove its nature. The smoky veiling could possibly be explained as remaining traces of the original flowing in the once-fluid silica.

Figure 8. Dark streamers in opal. Transmitted light, magnified  $50\times$ .

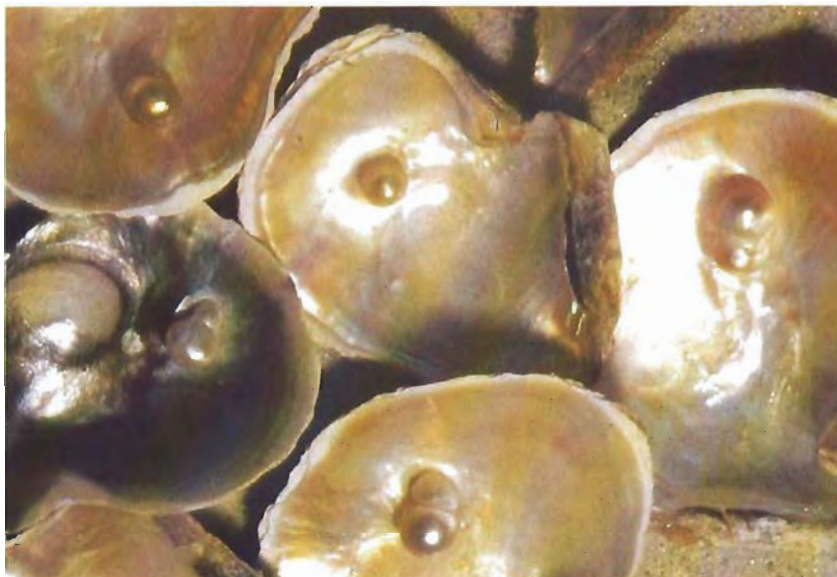
*Figure 11. Shells approximately 38 to 52 mm long that contain blister pearls.*

The New York laboratory received for testing several small (38 to 52 mm long) nacreous shells, of an unknown species, in which a pearl or blister pearl appeared near the adductor muscle scar (figure 11). The lab was unable to determine whether the "pearls" occurred naturally or were induced by man. X-ray photographs indicated natural pearls. Many of the "pearls" in the shells were not completely attached to the shell, and one appeared to be cemented to the shell. The client could not provide any information about these mysterious objects.

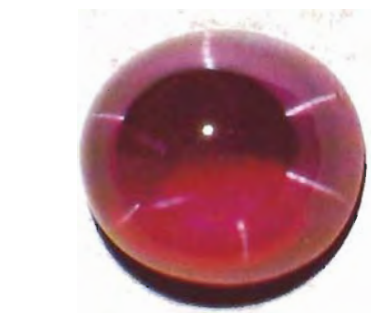
Another section of the same boule (toward the bottom) that was later worked into a stone contained part of the transparent seed crystal with a shallow overgrowth of the asteriated material. This material when cut produced a weak star with an open center caused by the non-asteriated seed-crystal section, a very unusual stone indeed (see figure 13).

Figure 13. Synthetic star ruby (4.22 ct) cut from a piece near the bottom of the boule from which the stone in figure 12 was cut. Note that the rays of the star do not meet in the center of the stone.

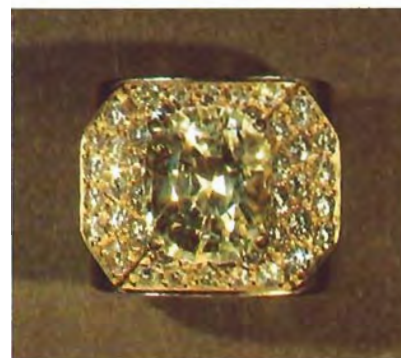
Several months ago a client sent to the Los Angeles laboratory a man's ring set with an 11.20 × 9.10 × 7.08 mm light yellow, oval, mixed-cut center stone and numerous diamond side stones. The client explained that during the resizing process the stone had changed color from a beautiful intense yellow to a light greenish yellow (see figure 14). The client was very puzzled by this change of color due to heating and questioned whether the stone was in fact a natural yellow sapphire. Testing, however, did prove it to be a natural sapphire.

Figure 14. Heat alteration to greenish yellow in a natural yellow sapphire, 11.20 × 9.10 × 7.08 mm.

Unfortunately, we hear of cases like this quite often (see "Jadeite" above for another example). The fact that sapphires and many other gemstones may lose or change color if heated, or even worse may fracture or break, is not fully understood by some jewelers and repairpeople.

Occasionally, we see rubies or sapphires that have etched surfaces. These damaged surfaces occur when repair work is done on an article of jewelry without removing the corundum from the setting. Damage results from the stone coming into contact with the usual fluxes con-

taining boron, in which corundum is soluble. Under high temperatures these fluxes, whether they are used as protective coatings or in pickling acids, become more active and may seriously attack and partly dissolve the surface of the stone. To prevent etched surfaces, the safest precaution is to remove the corundum before the mounting is repaired or pickled.

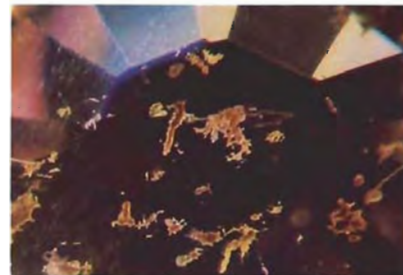
Pink spinels and red spinels have become much better known to the consumer and are being seen much more frequently in the trade both here and in the Orient. The New York lab has had the opportunity to examine several lots of stones totaling hundreds of carats. Among the collections were two stones that had unique inclusions. Figure 17 illustrates some root-like inclusions resembling those we have seen in another cubic mineral—diamond (see *Gems & Gemology*, Fall 1974, p. 332, and Fall 1979, p. 199). Figure 18 shows a series of frosted-appearing "tennis balls," which in reality are negative "crystals" that resemble the gas bubbles seen in slag glass. Figure 19 illustrates some of the more normal spinel inclusions, including octahedrons, seen in a handsome red spinel.

Figure 17. Unusual root-like inclusions in natural spinel. Dark-field illumination, magnified 20×.

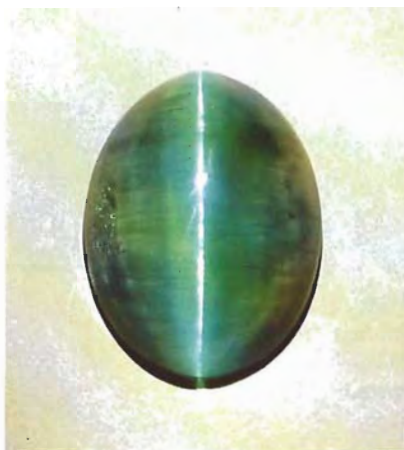
Among the many gemstones sent to the Los Angeles laboratory for identification, cat's-eye tourmalines are sometimes seen. The most common colors are various shades of pink, red, green, and blue. In the majority of these stones, tubes or needle-like inclusions throughout the entire stone give rise to chatoyancy when the stone is cut en cabochon. Figure

20 shows an exceptional 258.08-ct green tourmaline with a sharp eye.

Figure 20. Exceptional green cat's-eye tourmaline, 258.08 ct.
